CENTRAL UTAH WATER

Corrosion Case Studies in the Water Industry

William Garner, P.E.

SIEO - January 2023

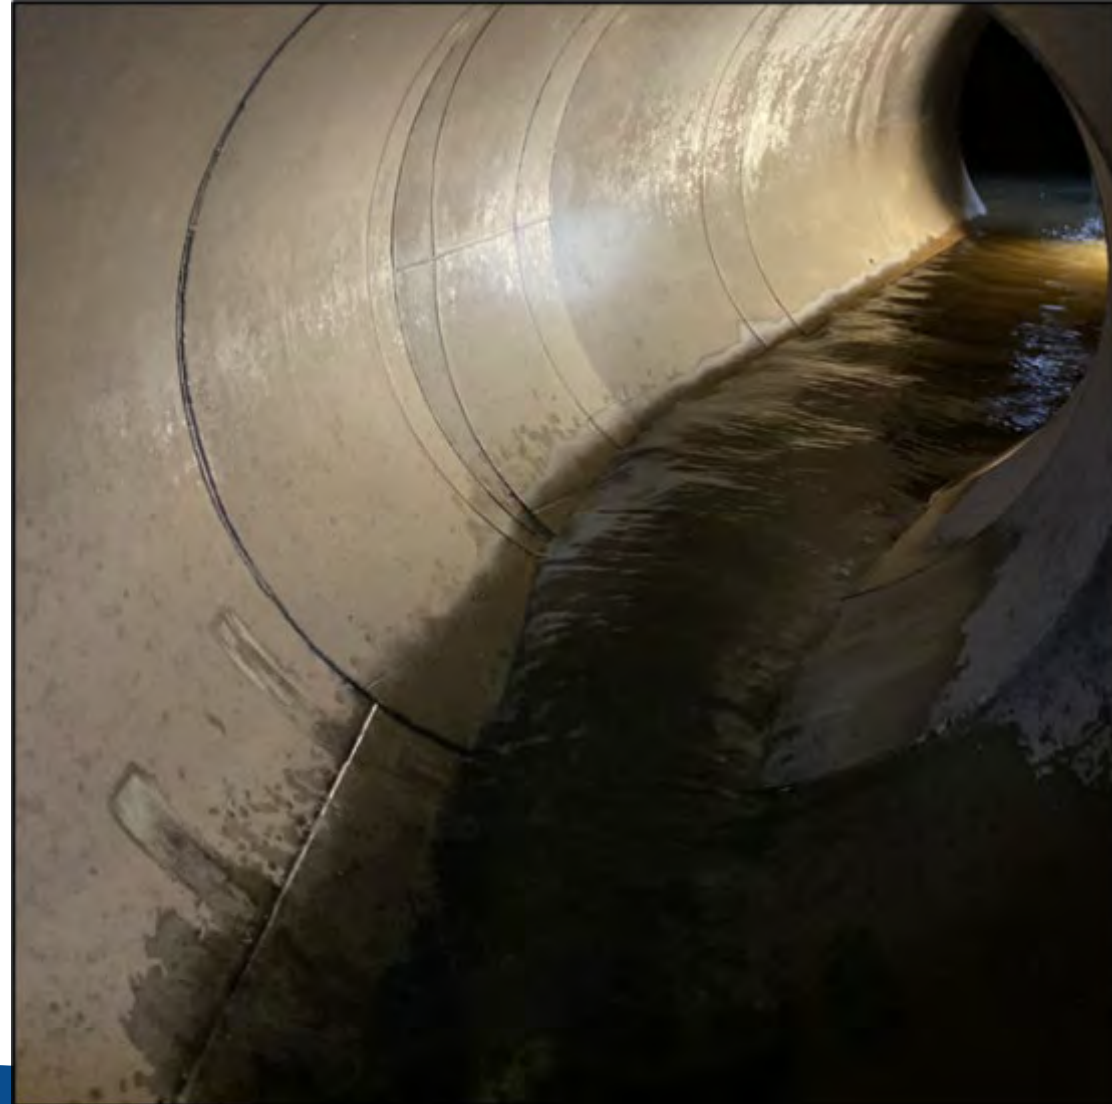
Coating Failure and Pitting Corrosion

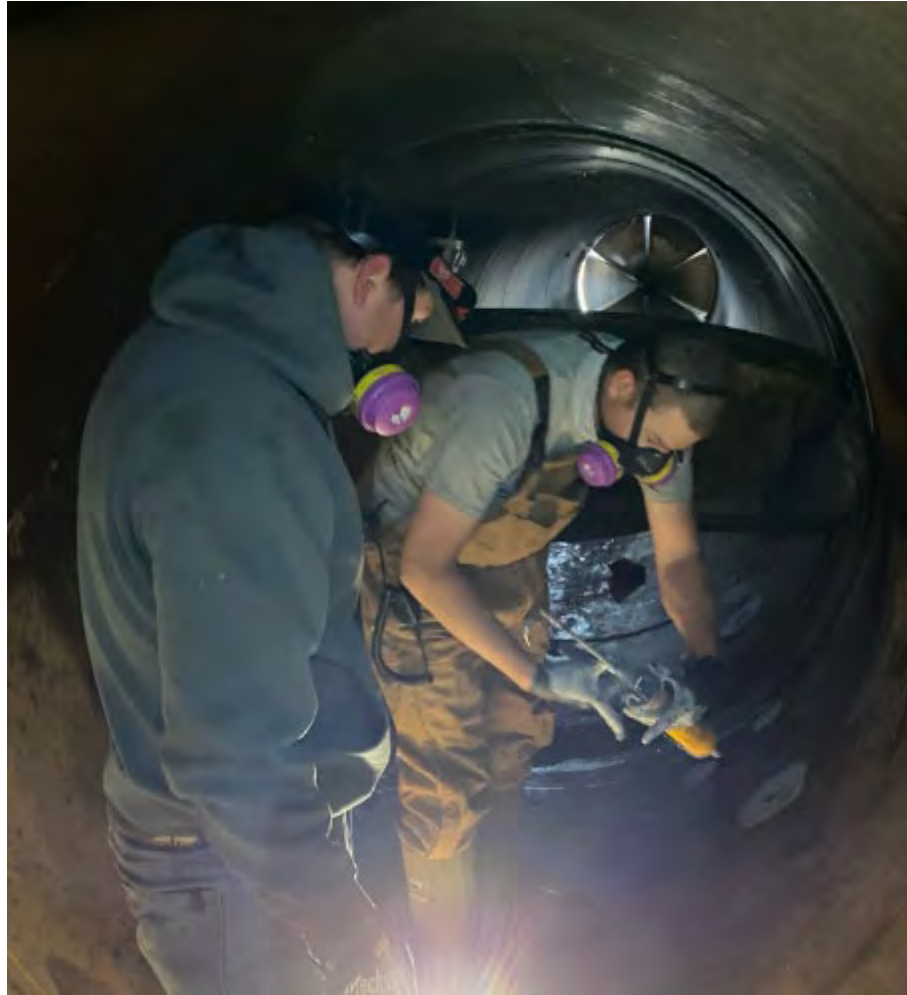
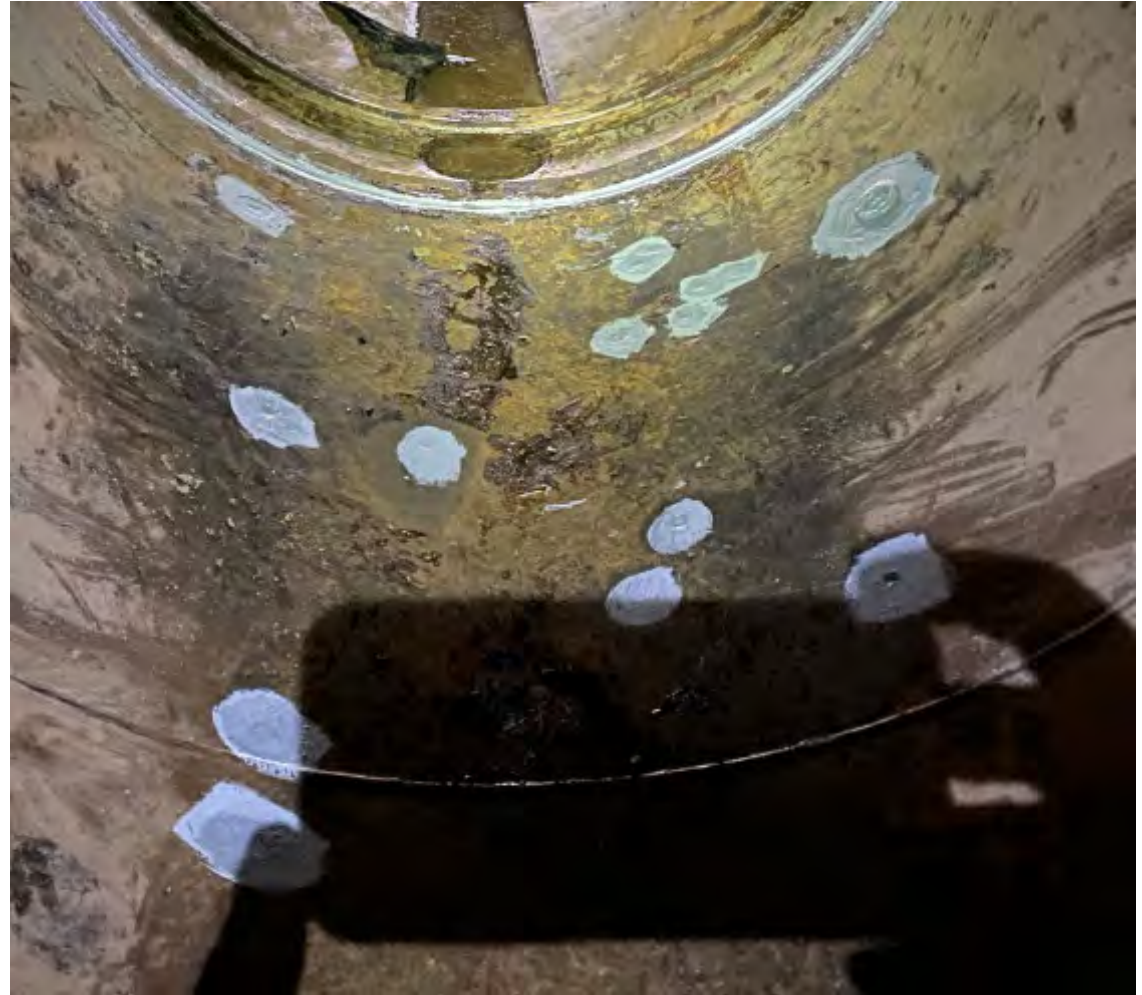
Coating and Pitting Repairs

- Abrasive Blast and Re-Coat
- 10,000 square feet
- Schedule: 10-day shut down window
 - One day planned for corrosion/ pitting repairs found after abrasive

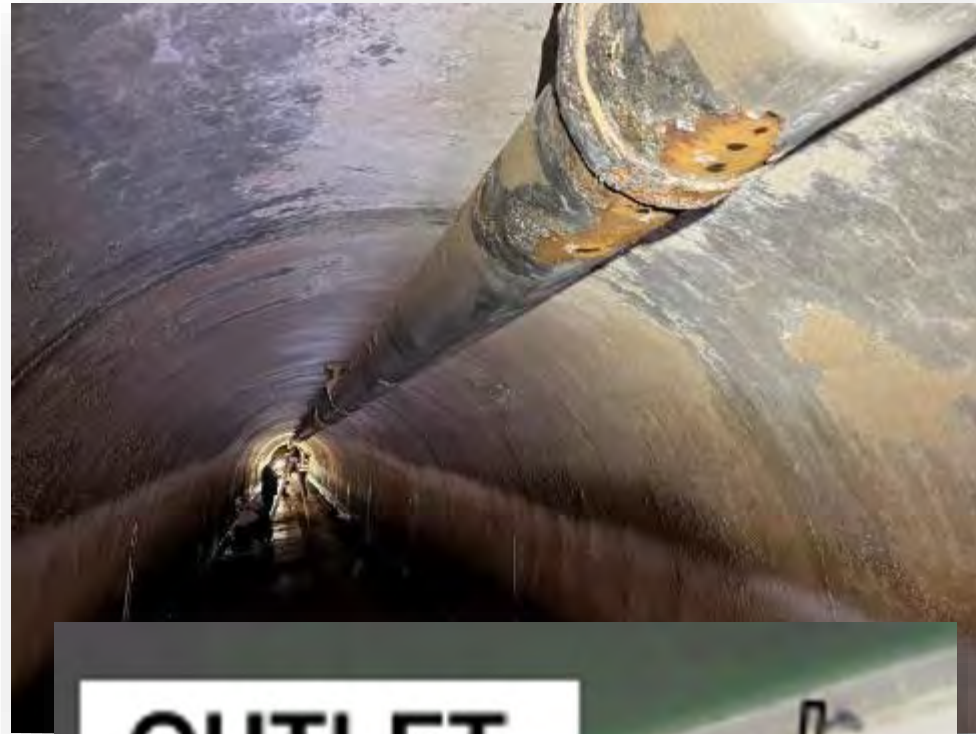
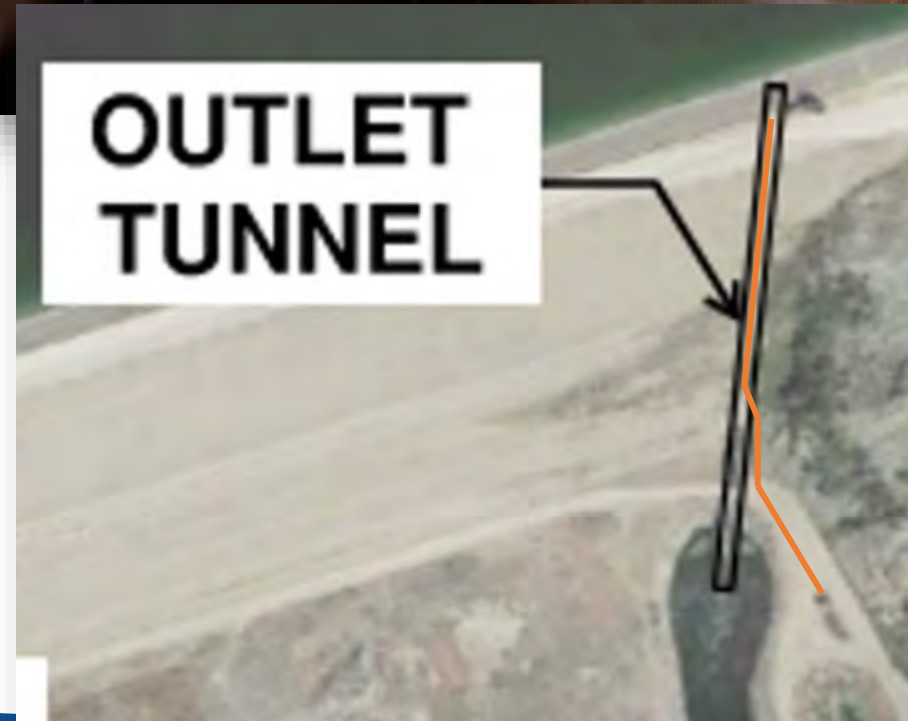
Tunnel and 12" Bypass

- Installed in Year 1970
 - Note – Over 50 years of service

O&M Recommendation: Repair or replace the corroded outlet bypass pipeline and couplers

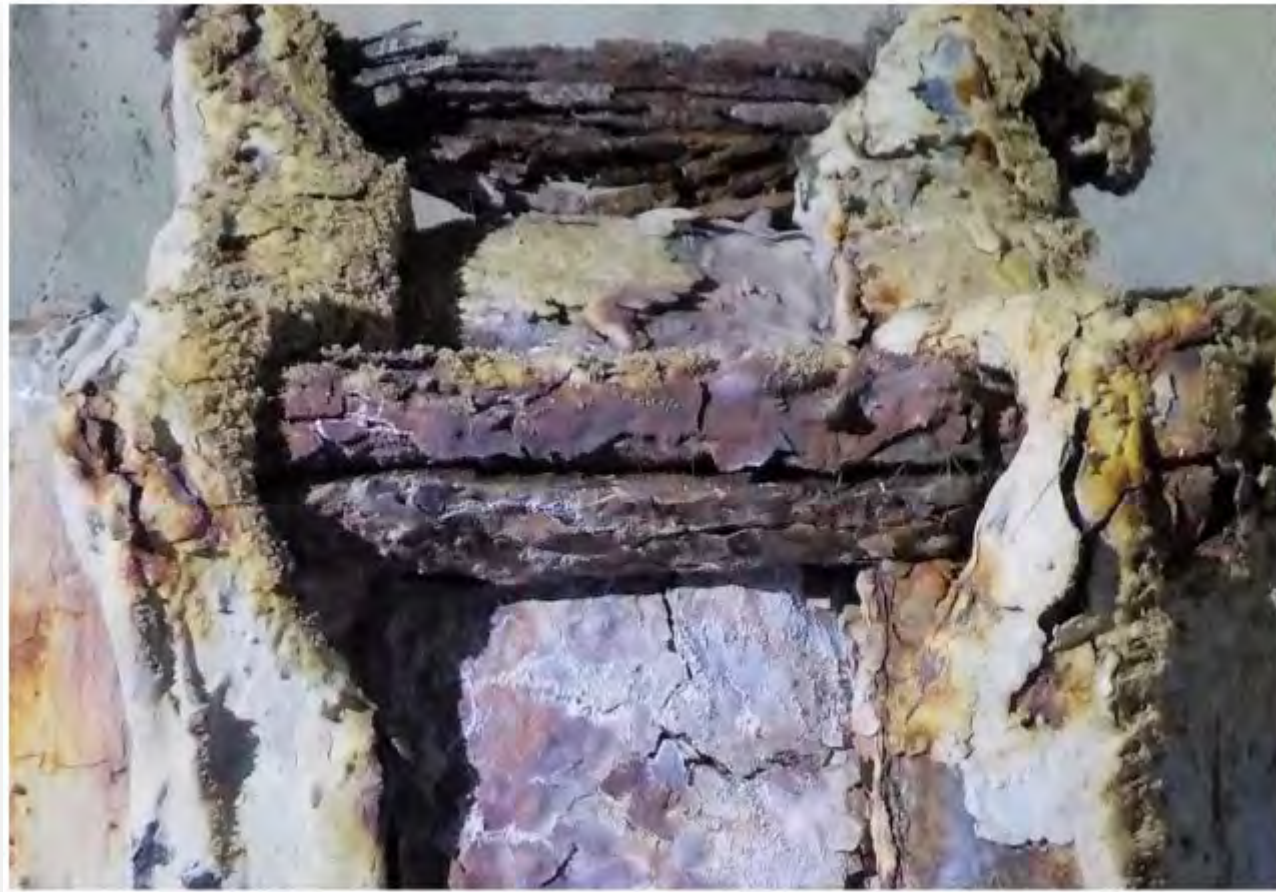
Typical Coupling Bolt Damage Spool 3 & 4

- Repair & Re-Coat
 - Bracket would still need to be replaced
- Full replacement
 - More expensive, but longer lasting
 - Design and Build

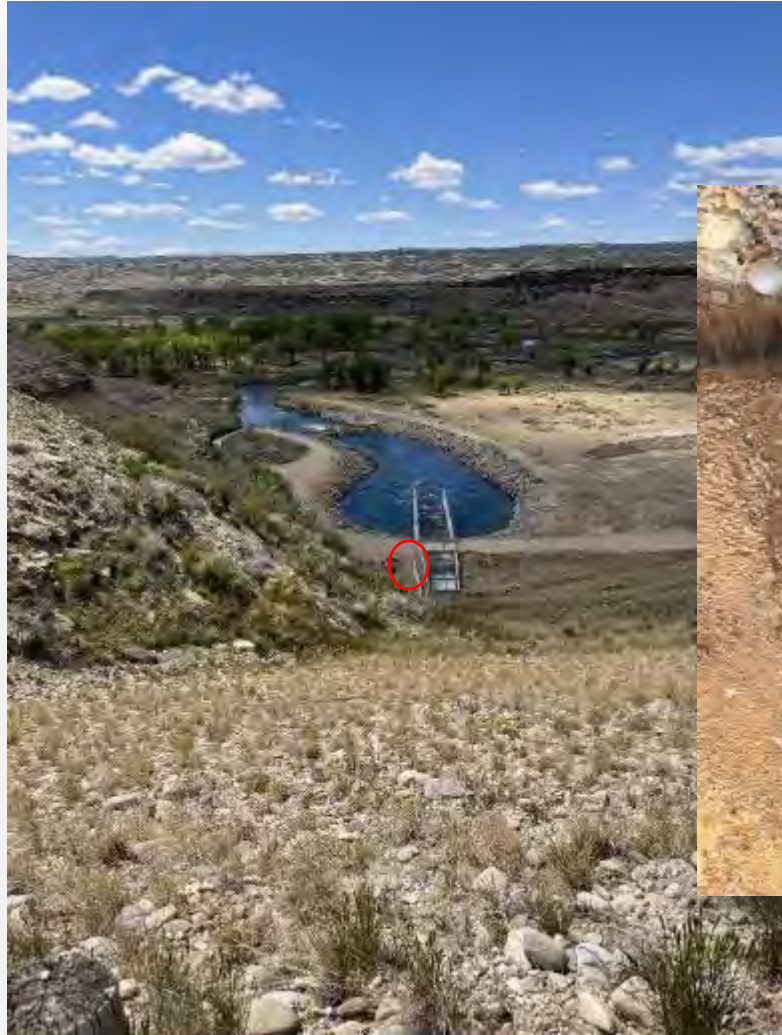
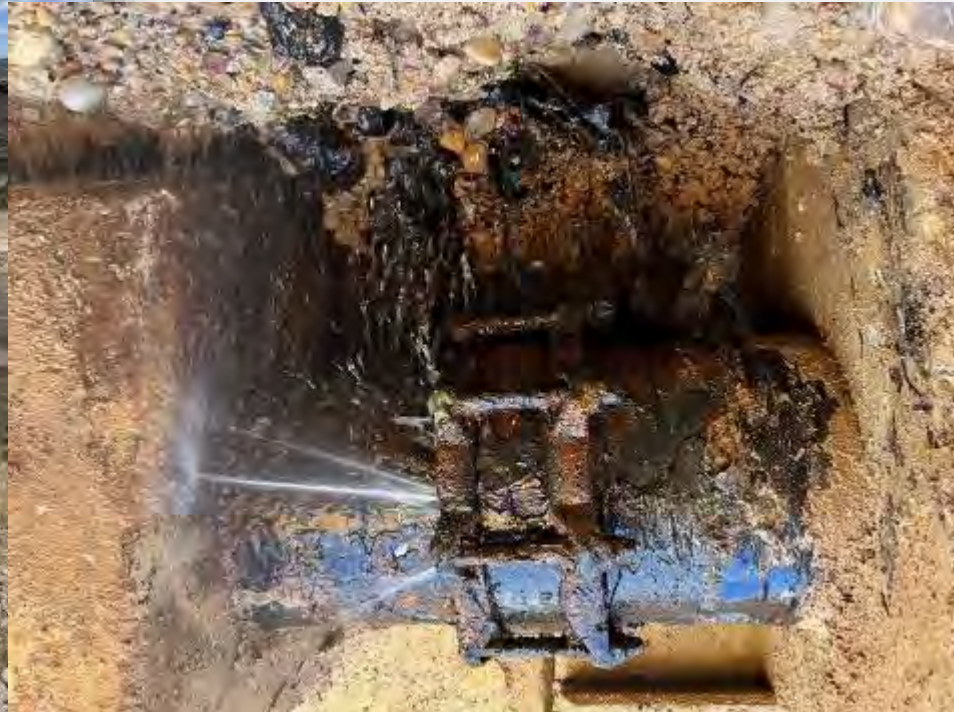
Integrity Digs

- Pipe – Fairly good condition. Little internal corrosion and external corrosion
- Bracket Hanger – Replace as soon as possible
- Buried Pipe - Wing Wall settling caused leak and needs to be replaced

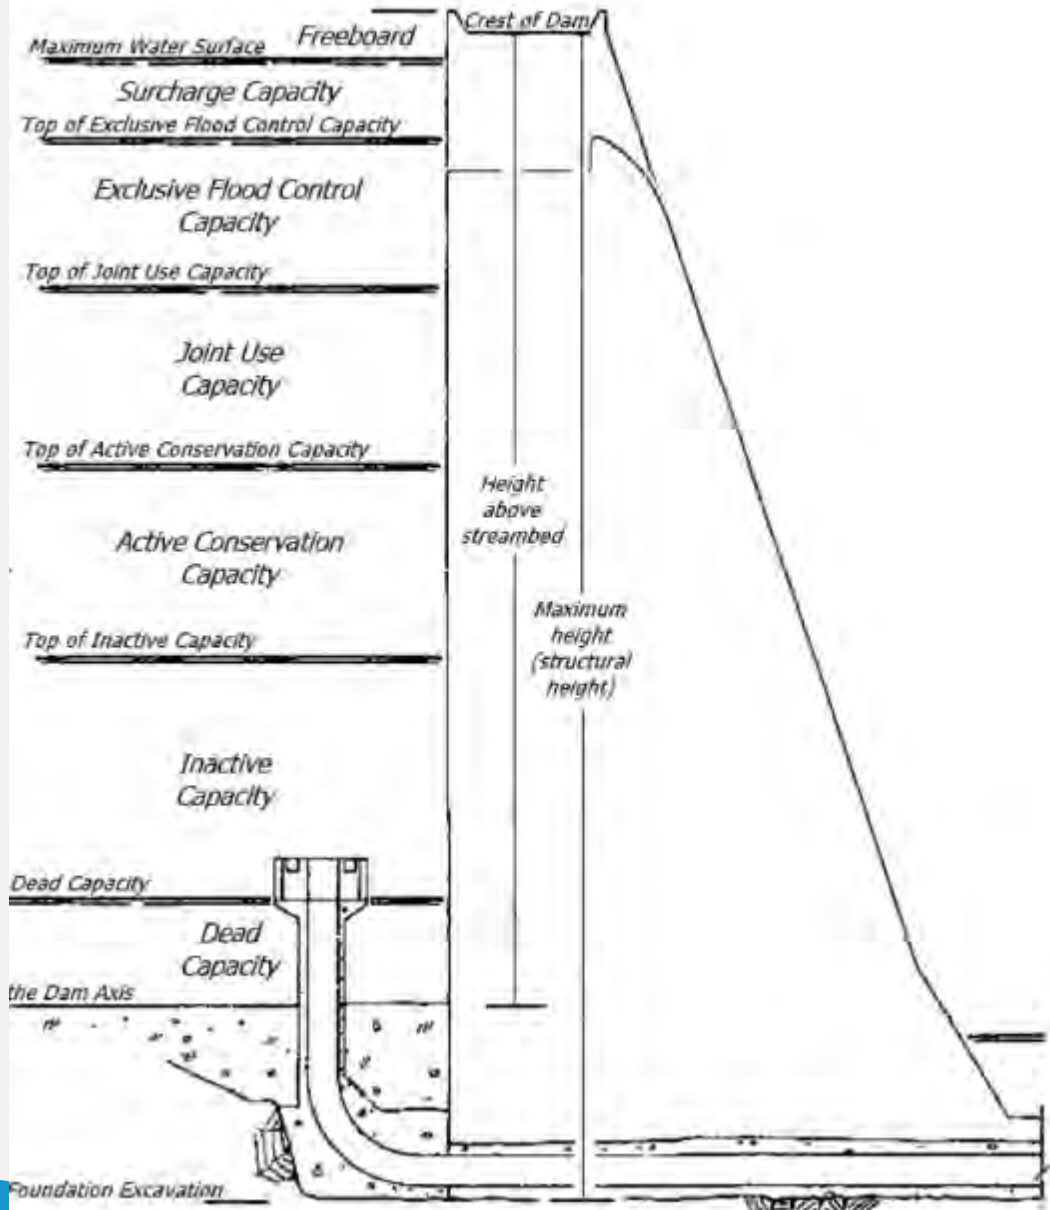
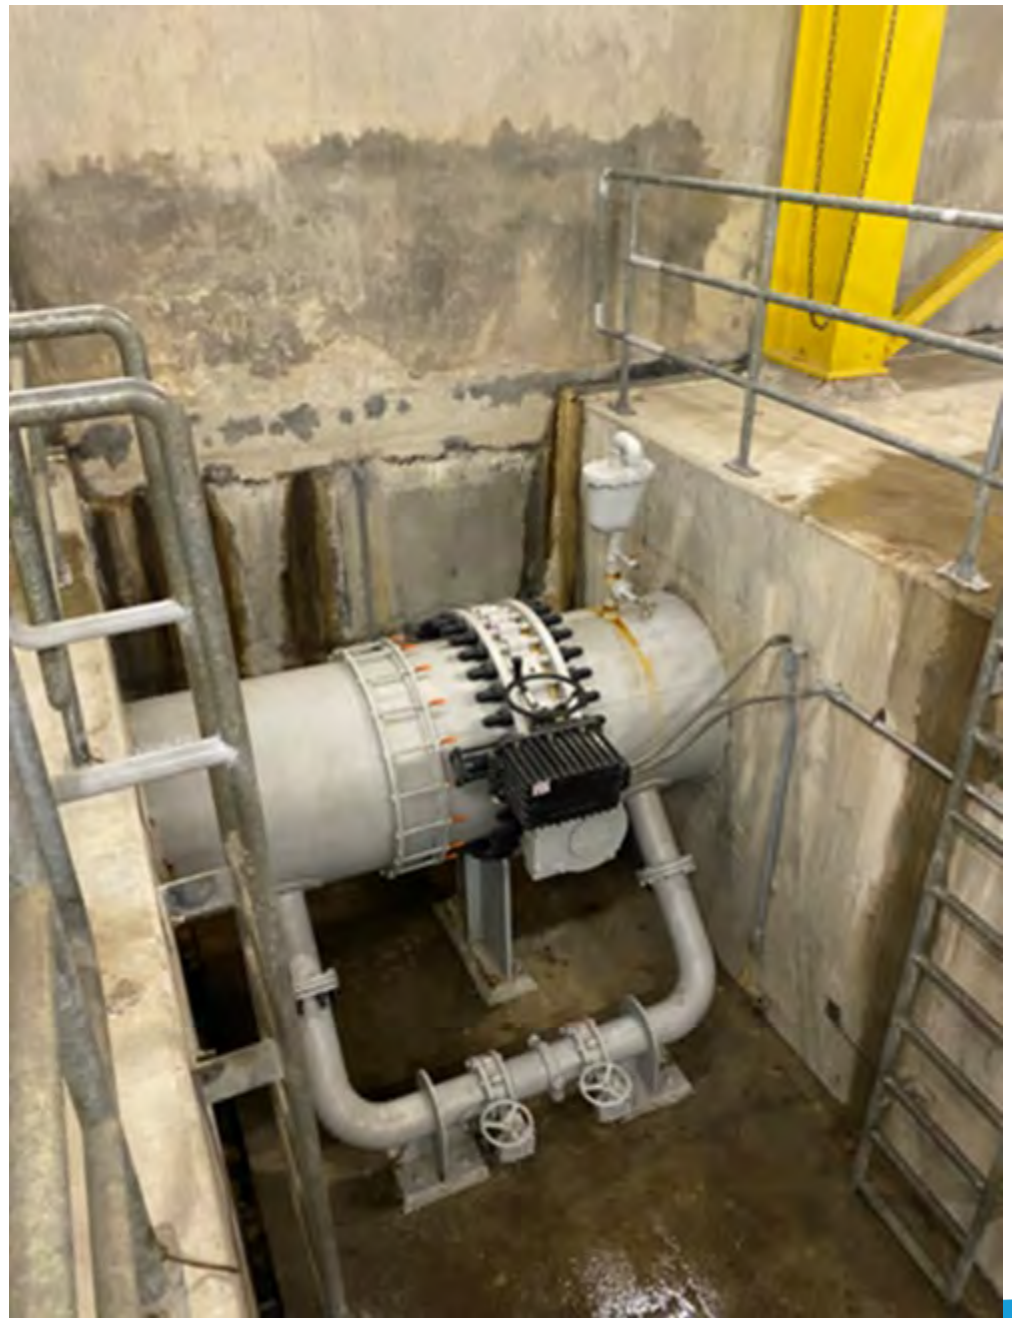
Stainless Steel Valve – Located Inside an Untreated Water Tank

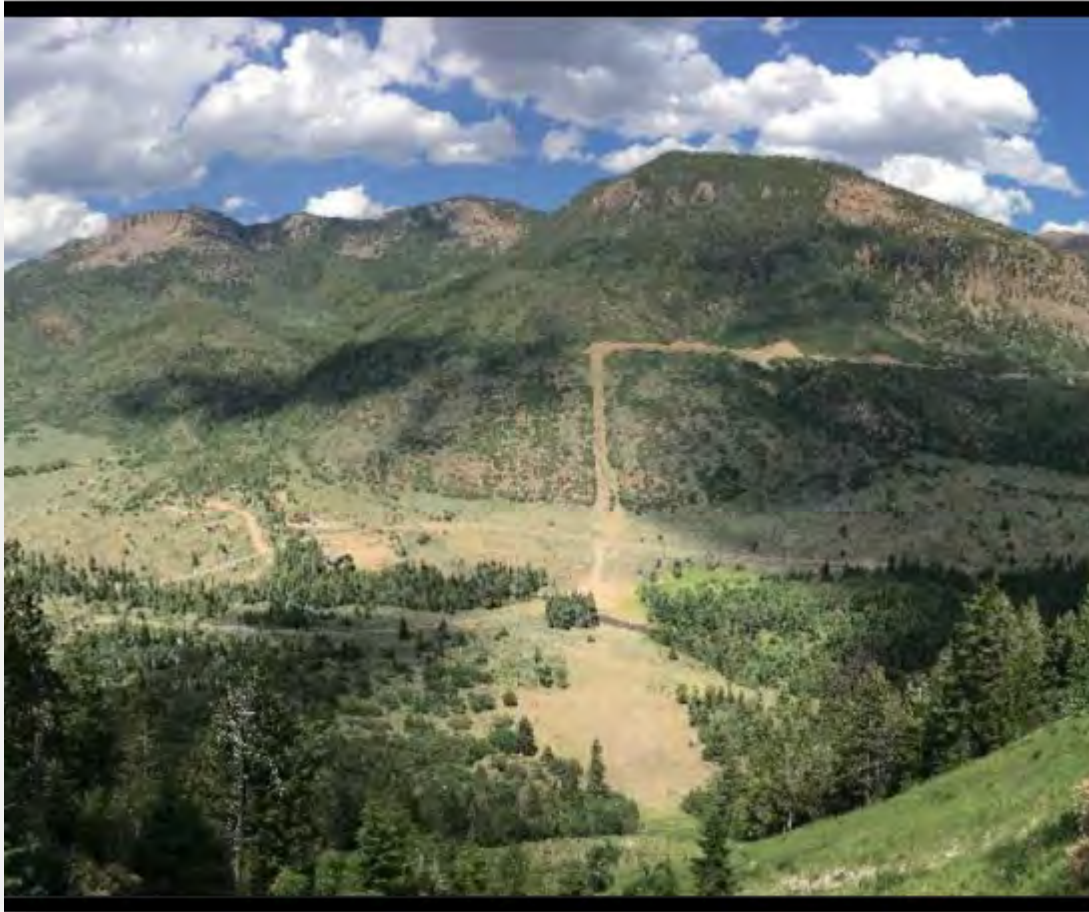
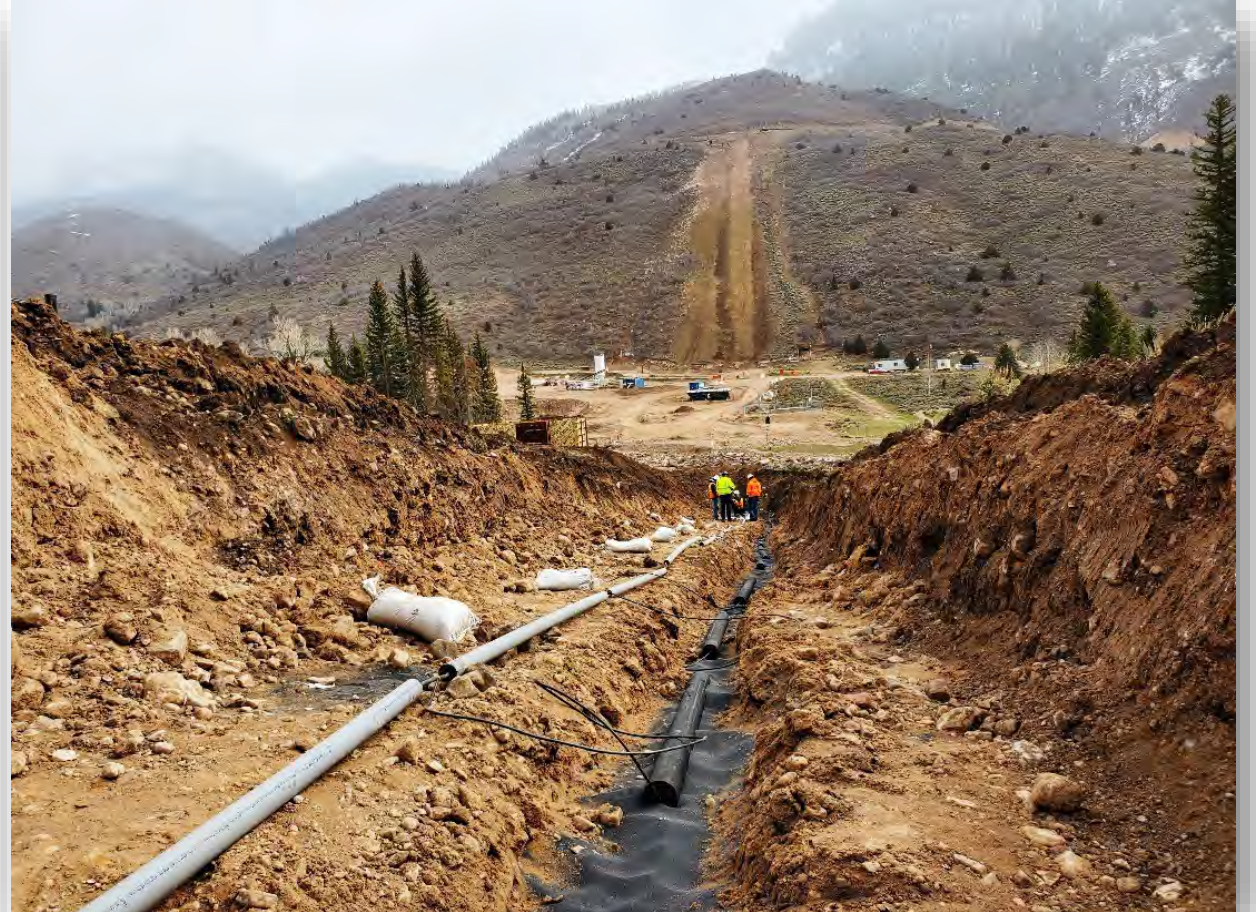
North Fork Siphon Blowoff Shorting
