CENTRAL UTAH WATER

Corrosion Case Studies in the Water Industry

William Garner, P.E.

SIEO - January 2023

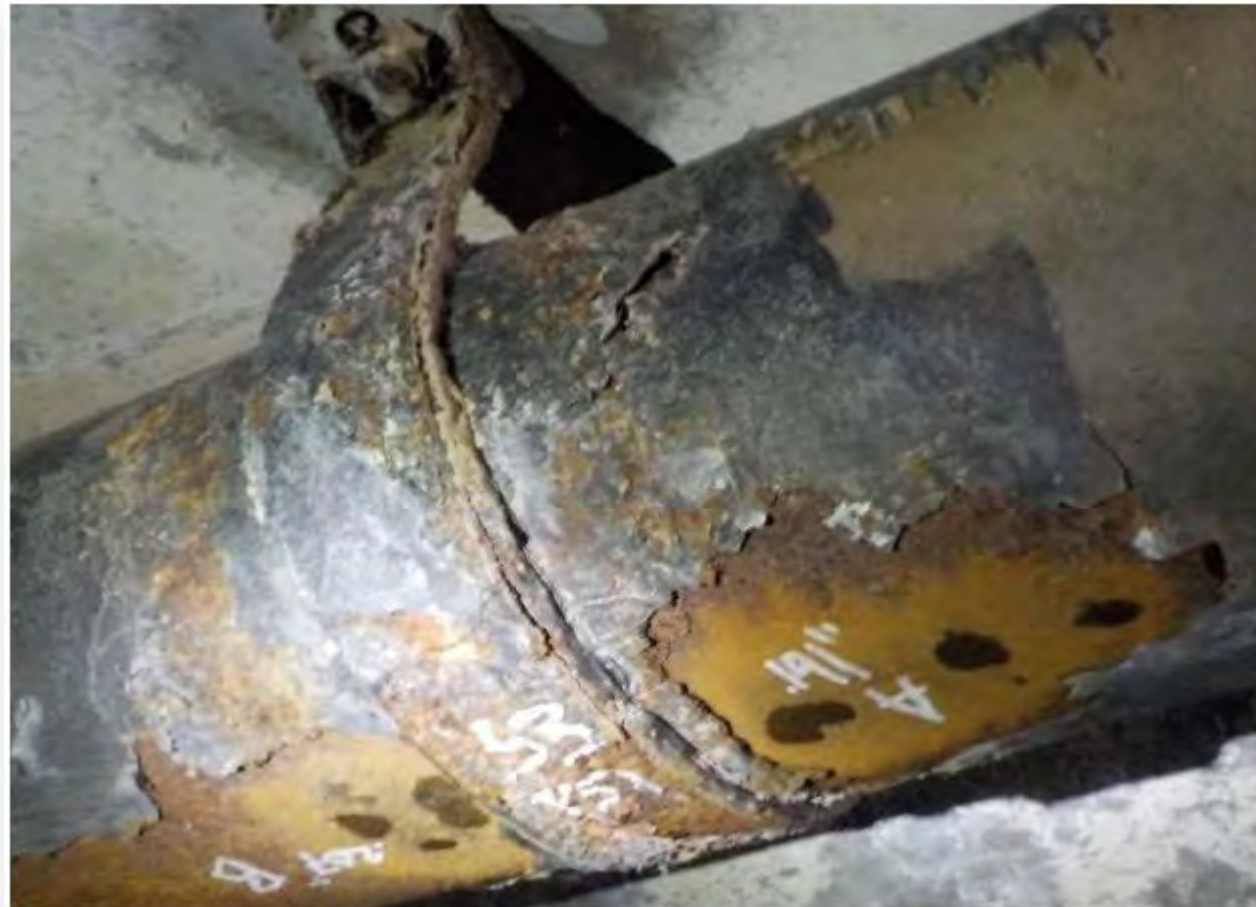
Blister Cleanup and UT Evaluation

Lowest Pipe Thickness Reading .191" Spool 3
