CENTRAL UTAH WATER

Corrosion Case Studies in the Water Industry

William Garner, P.E.

SIEO - January 2023

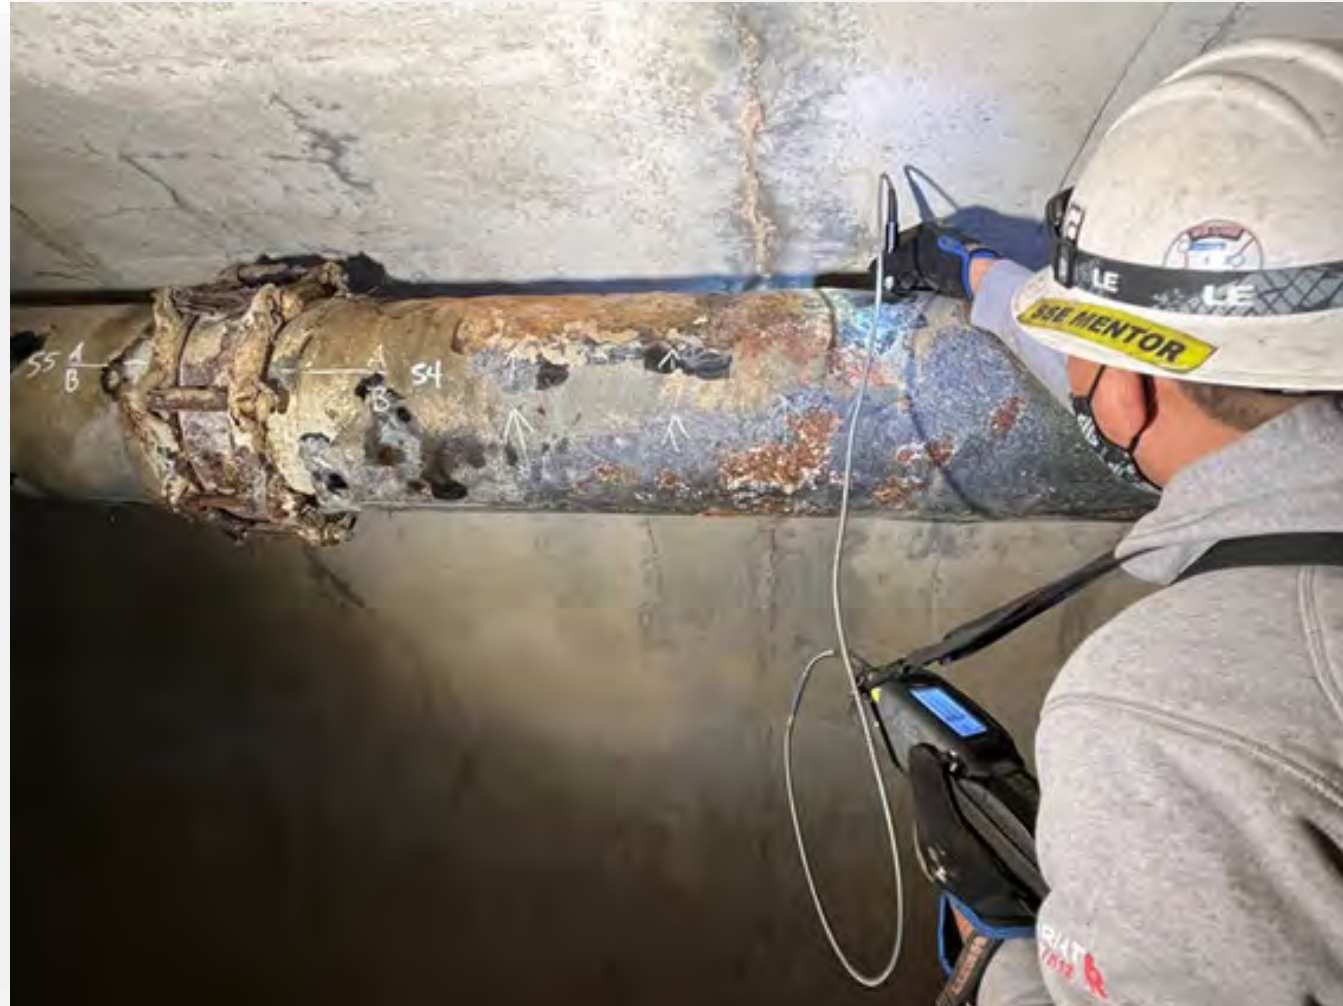
Ultrasonic – Hand Scan

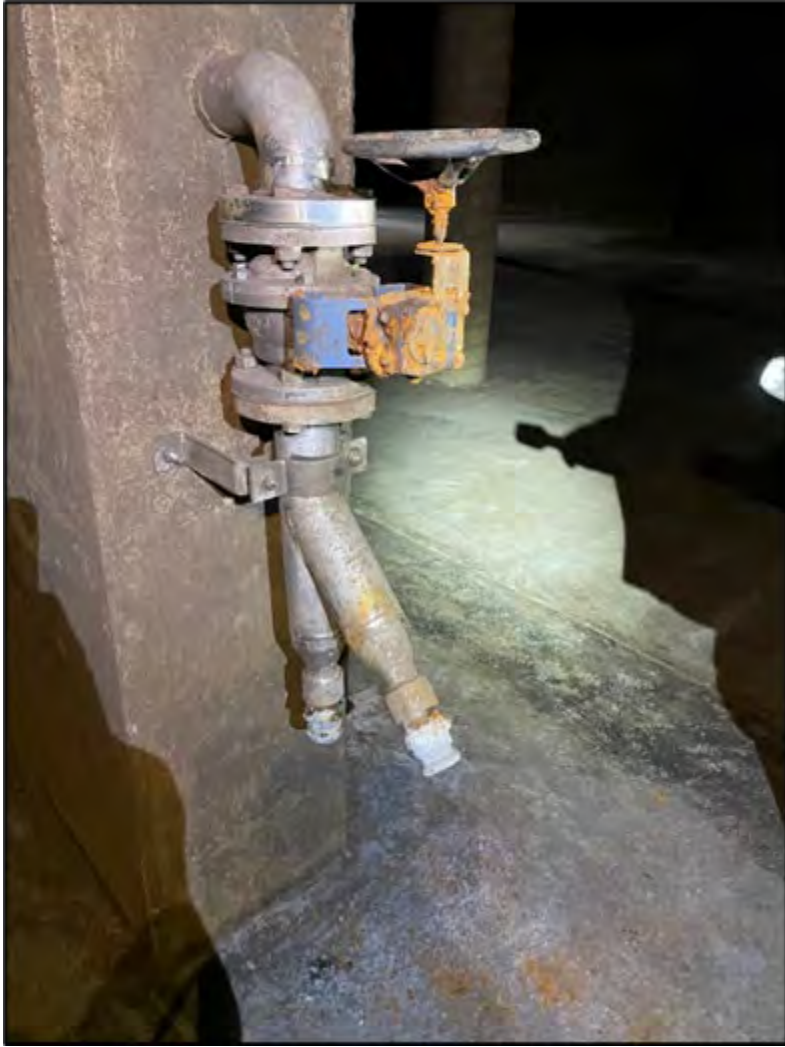
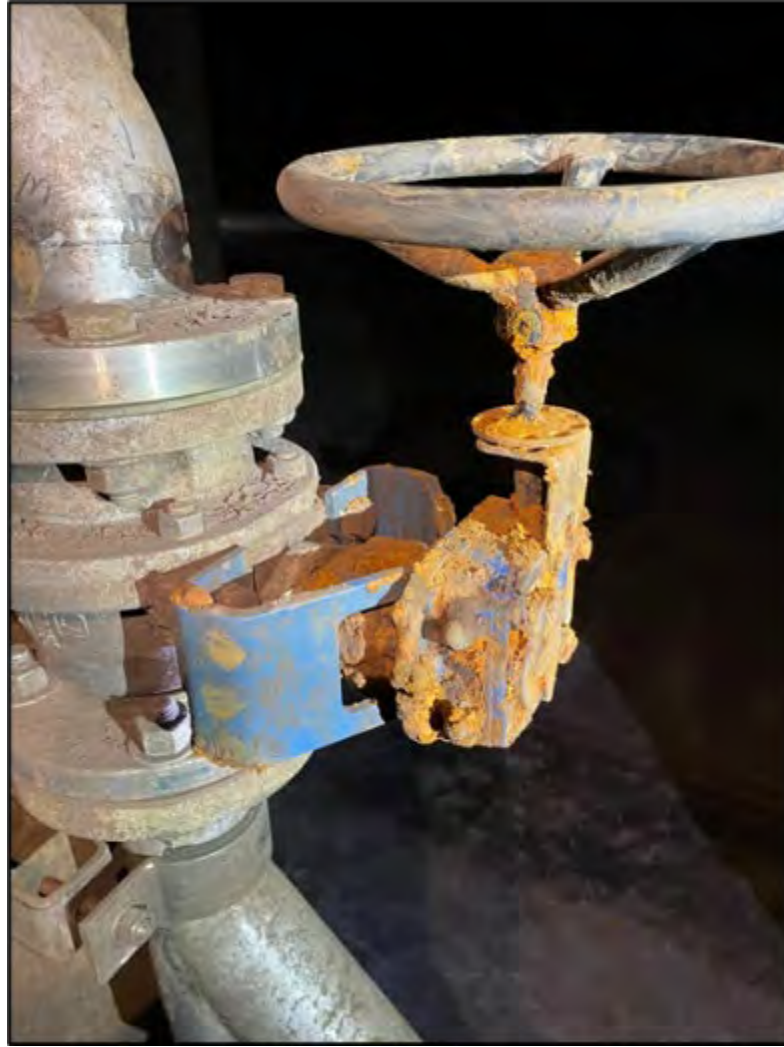
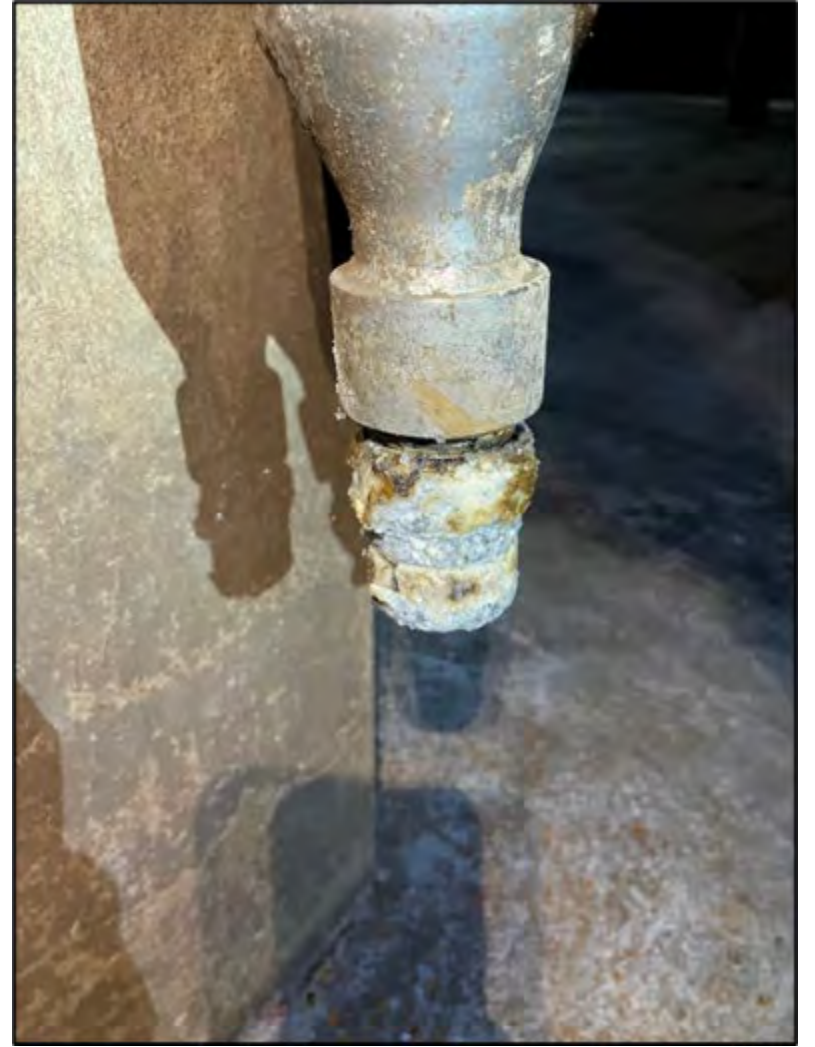
Stainless Steel Valve – Located Inside an Untreated Water Tank

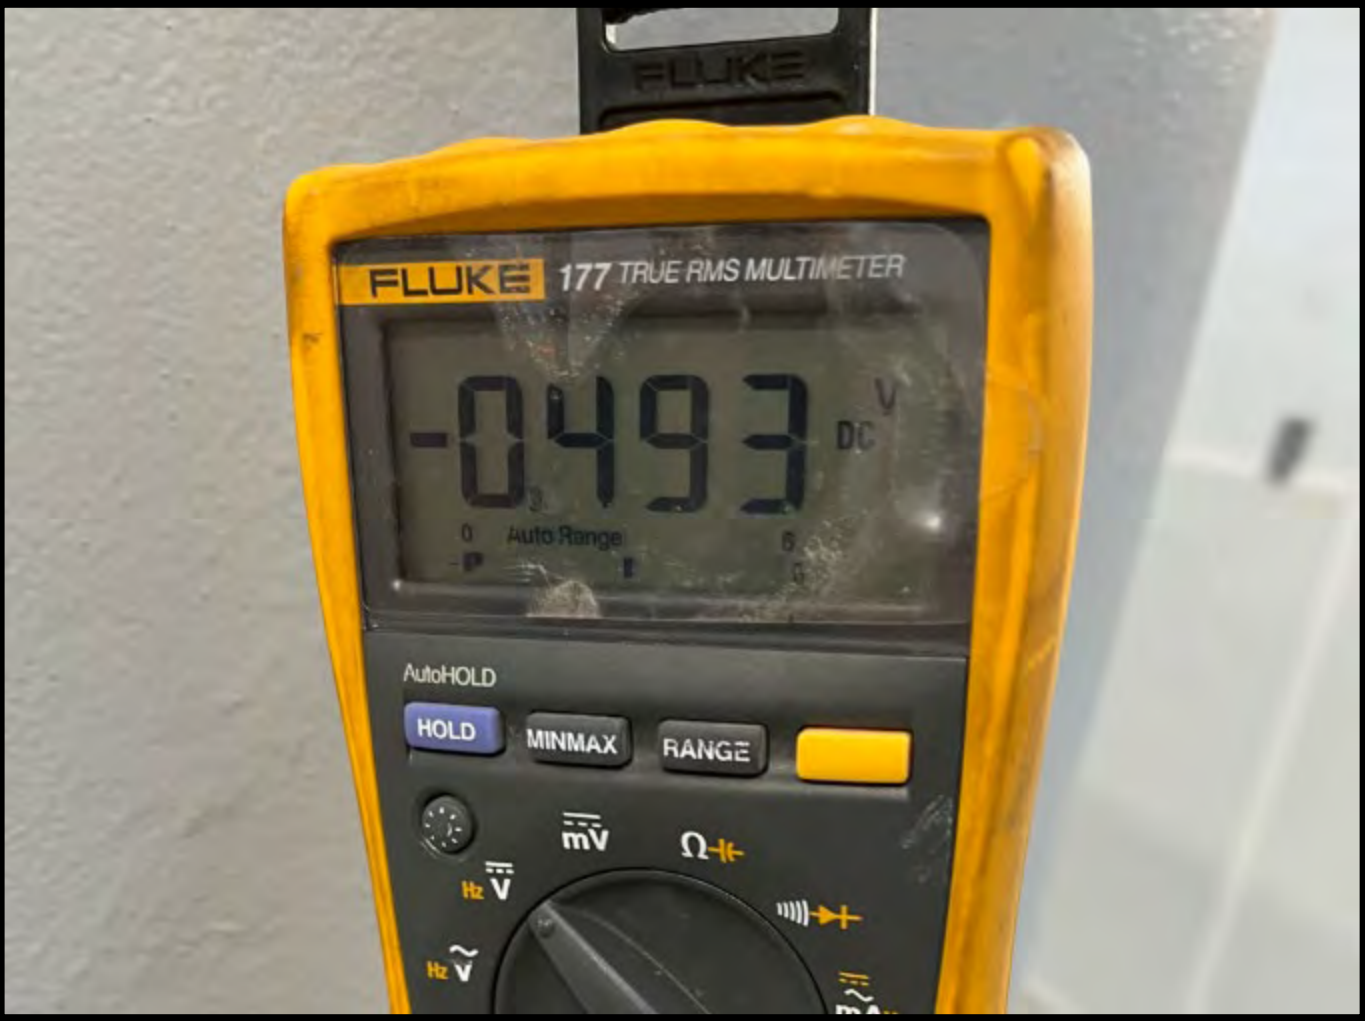
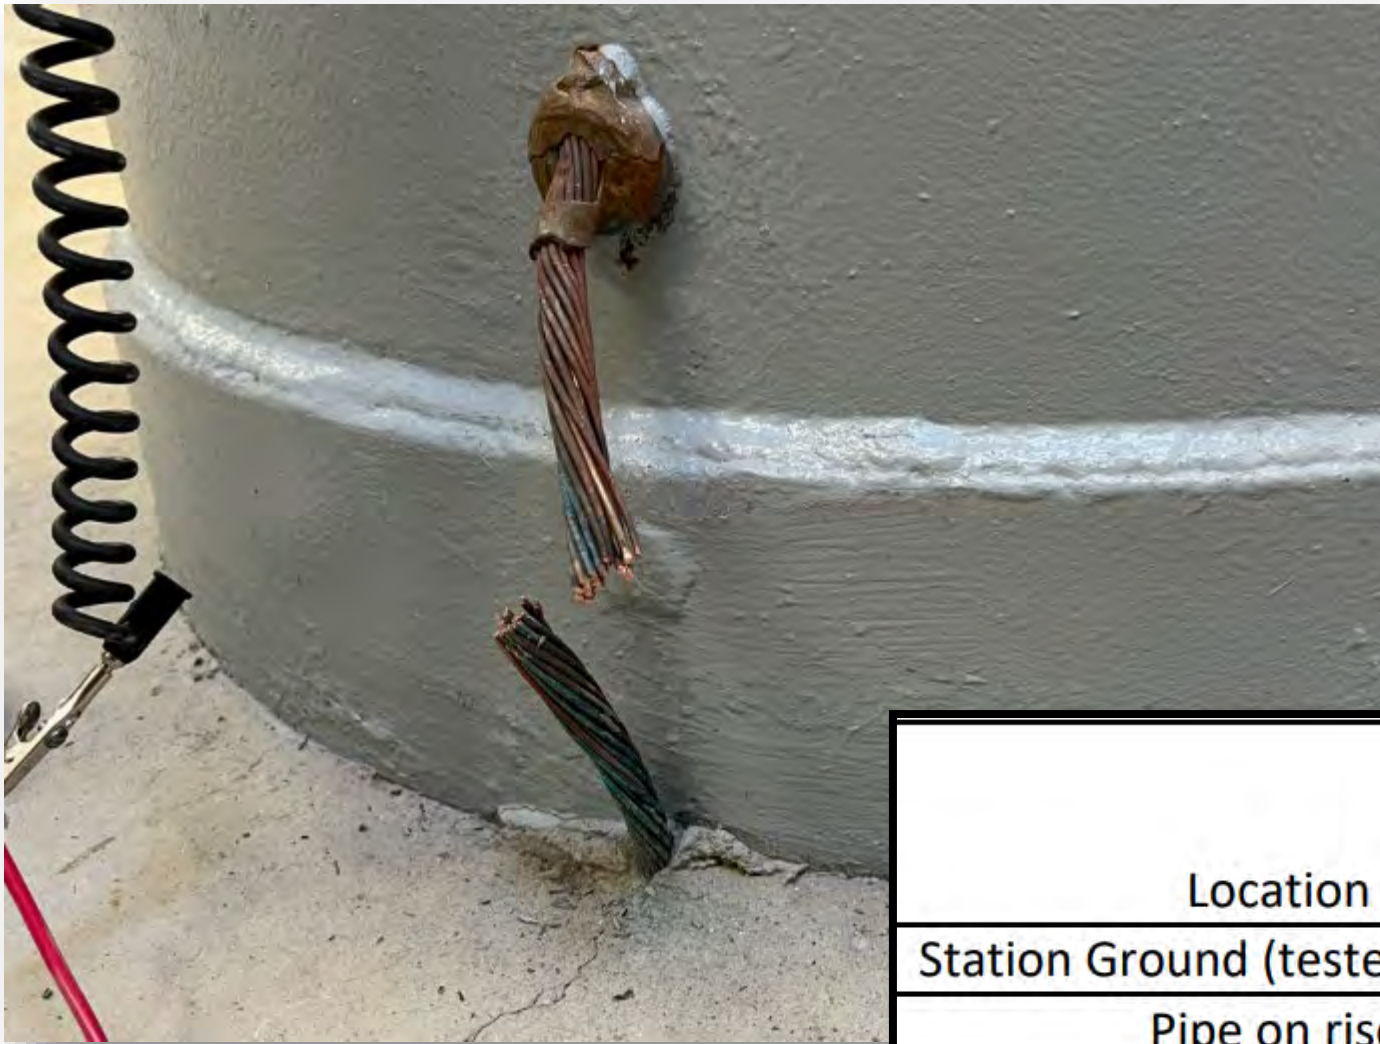
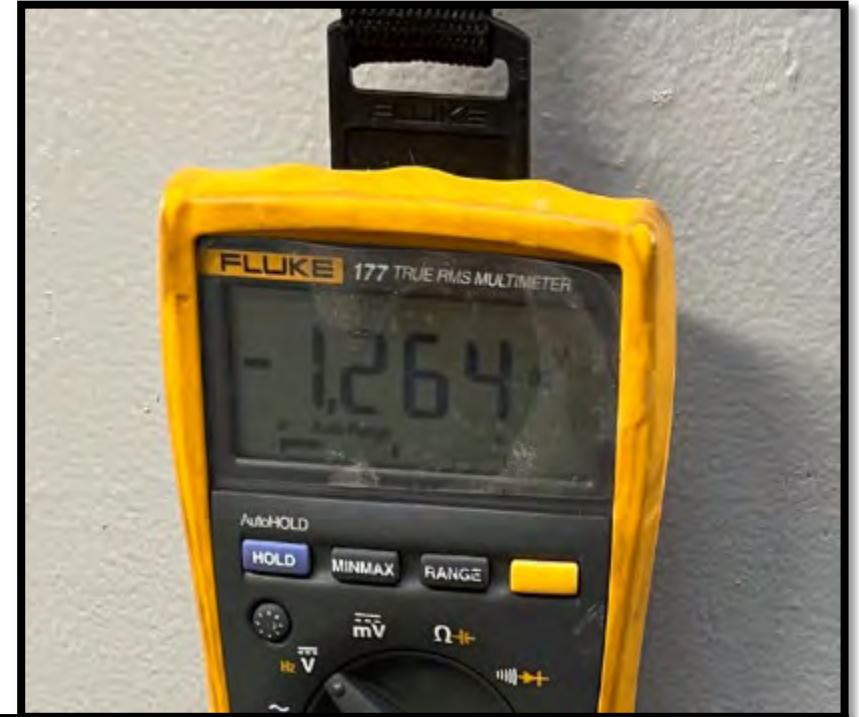
Isolation Flange Passed RF-IT Isolation Flange Check

Location	P/S Before (Vdc)	P/S After (Vdc)
Station Ground (tested on ladder)	-0.756	-0.49
Pipe on riser	-0.78	-1.262
Test station	-0.805	-1.152
Test station	-0.515	-1.152

- Inspection During Construction
- Annual Survey
- Methodically Evaluate Possible Shorting locations
- NACE SP0286 “Electrical Isolation of Cathodically Protected Pipelines”
